**Flood Control Project Maintenance
Levee Inspections**

Maintenance Issue Types Only, Levee Inspection Report By Mile - Spring 2016

Reclamation District No. 2095 Paradise Cut

Waterway	Bank	Unit Miles	Inspection Start/End	Inspector
Unit No. 01 Paradise Cut	Left	1.45	04/05/2016 04/05/2016	Maksim Khashchuk

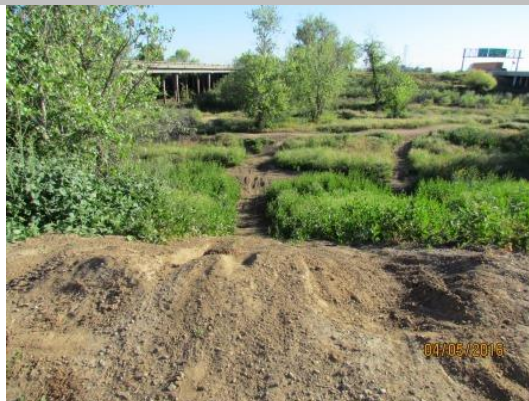
Photo 1 of 1 : SP_2016_RD2095_322_3_20160412_00025.jpg

LM Start	0.07	Rating **	M	Issue No.	3
LM End	0.07	Issue Type +	Ma	Location *	WS
Category	Earthen Levee			GPS Latitude/Longitude	
				Start	End
Item	Slope Stability			37.770544 °	37.770544 °
				-121.326193 °	-121.326193 °
DWR ID	DWR_RD2095_01_s _ 2016_3				
Comment Code					
S3 : Repair the levee slope damaged by vehicle traffic and prevent access where possible.					
Inspector Comment

View of the vehicle tracks on the waterside levee slope.

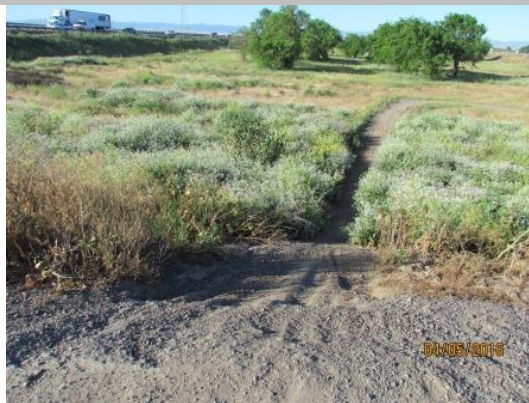
Photo 1 of 1 : SP_2016_RD2095_322_12_20160412_00026.jpg

LM Start	0.09	Rating **	M	Issue No.	12
LM End	0.09	Issue Type +	Ma	Location *	LS
Category	Earthen Levee			GPS Latitude/Longitude	
				Start	End
Item	Slope Stability			37.770429 °	37.770429 °
				-121.325986 °	-121.325986 °
DWR ID	DWR_RD2095_01_s _ 2016_12				
Comment Code					
S3 : Repair the levee slope damaged by vehicle traffic and prevent access where possible.					
Inspector Comment

View of the vehicle tracks on the landside levee slope.

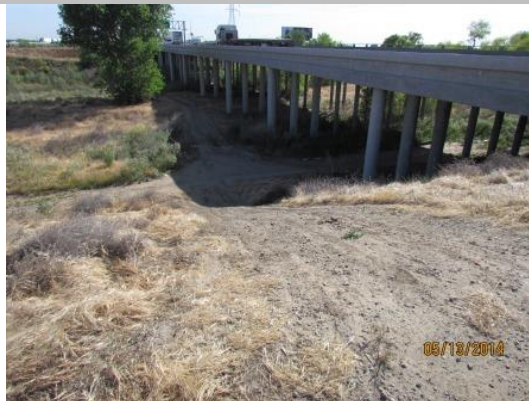
Photo 1 of 1 : SP_2016_RD2095_322_134_20160229_00010.jpg

LM Start	0.11	Rating **	M	Issue No.	134
LM End	0.11	Issue Type +	Ma	Location *	WS
Category	Earthen Levee			GPS Latitude/Longitude	
				Start	End
Item	Slope Stability			37.770212 °	37.770212 °
				-121.325675 °	-121.325675 °
DWR ID	DWR_RD2095_01_s _ 2014_134				
Comment Code					
S3 : Repair the levee slope damaged by vehicle traffic and prevent access where possible.					
Inspector Comment

View of the vehicle access on the waterside levee slope.

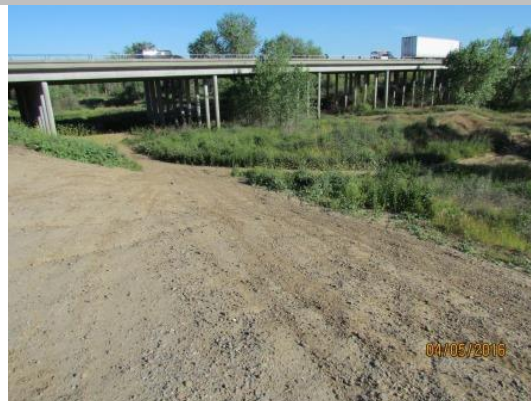
Photo 1 of 1 : SP_2016_RD2095_322_10_20160412_00027.jpg

LM Start	0.15	Rating **	M	Issue No.	10
LM End	0.15	Issue Type +	Ma	Location *	WS
Category	Earthen Levee			GPS Latitude/Longitude	
				Start	End
Item	Slope Stability			37.769997 °	37.769997 °
				-121.325055 °	-121.325055 °
DWR ID	DWR_RD2095_01_f_2015_10				
Comment Code					
S3 : Repair the levee slope damaged by vehicle traffic and prevent access where possible.					
Inspector Comment

View of the vehicle tracks on the waterside levee slope.

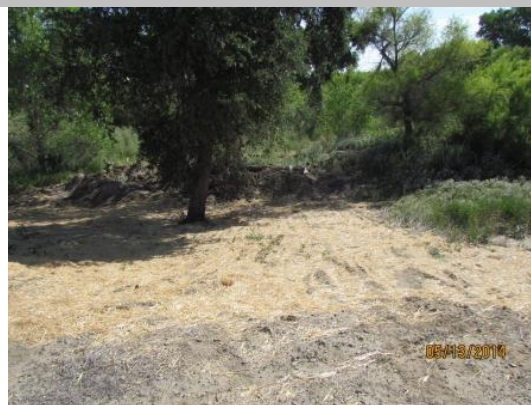
Photo 1 of 1 : SP_2016_RD2095_322_13_20160229_00009.jpg

LM Start	0.42	Rating **	A/W	Issue No.	13
LM End	0.42	Issue Type +	Ma	Location *	WS
Category	Earthen Levee			GPS Latitude/Longitude	
				Start	End
Item	Slope Stability			37.766917 °	37.766917 °
				-121.322267 °	-121.322267 °
DWR ID	DWR_RD2095_01_s_2013_13				
Comment Code					
S3 : Repair the levee slope damaged by vehicle traffic and prevent access where possible.					
Inspector Comment					
LMA is actively controlling the slope instability.

View of the repaired waterside levee slope.

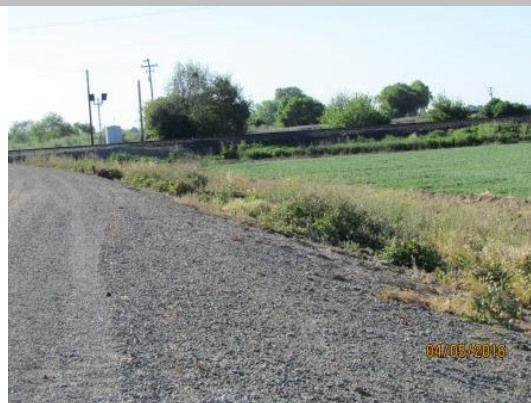
Photo 1 of 1 : SP_2016_RD2095_322_5_20160412_00028.jpg

LM Start	0.62	Rating **	M	Issue No.	5
LM End	0.69	Issue Type +	Ma	Location *	LS
Category	Earthen Levee			GPS Latitude/Longitude	
				Start	End
Item	Vegetation			37.764481°	37.763897°
				-121.320249°	-121.319164°
DWR ID	DWR_RD2095_01_s_2016_5				
Comment Code					
V1 : Control annual grass and weeds on the levee slopes and easements.					
Inspector Comment

View of the vegetation on the landside levee slope.

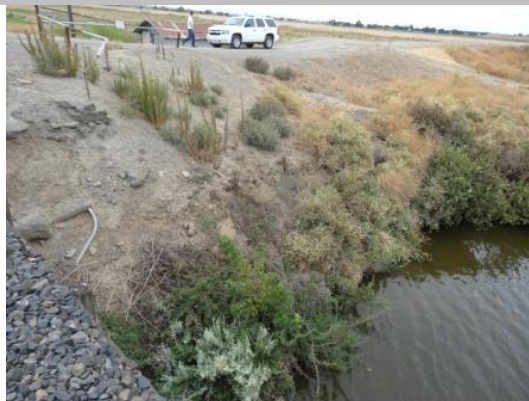
Photo 1 of 2 : SP_2016_RD2095_322_1_20160229_00001.jpg

LM Start	0.72	Rating **	M	Issue No.	1
LM End	0.73	Issue Type +	Ma	Location *	WS
Category	Supplemental			GPS Latitude/Longitude	
				Start	End
Item	DWR Erosion Survey			37.763630 °	37.763630 °
				-121.319000 °	-121.319000 °
DWR ID	DWR_RD2095_01_s_2016_1

Comment Code					
Inspector Comment					
08/04/2015: No significant change observed.					
08/26/2014: No significant change observed.					
08/28/2013: No significant change observed.					
07/18/2012: No significant change observed.					
09/02/2011: No significant change observed.					
09/22/2010: No significant change observed. There is now considerable vegetation at the water line and along the lower berm slope. However, the erosion on the lower berm slope is still present and has not been corrected.					
08/06/2010: Recommended for local maintenance issue, per CLRO.					
07/29/2009: No major change since last visit; noticeable vegetation growth; erosion is on berm, but if left untreated, it will eventually erode into levee prism; site is recommended for annual assessment and monitoring of the site, per CLRO CES 2008 Report; Site # is the same as RM6.80,LM0.73; previously rated "U".					
07/22/2008: Downstream of WPRR near siphon pipe & pump; sandy levee; visited by Jeff Van Gilder and LRO in 2008 for repair assessment; scouring downstream of RR crossing, possibly caused by eddy effects.

Close view of the erosion downstream of the RR bridge.

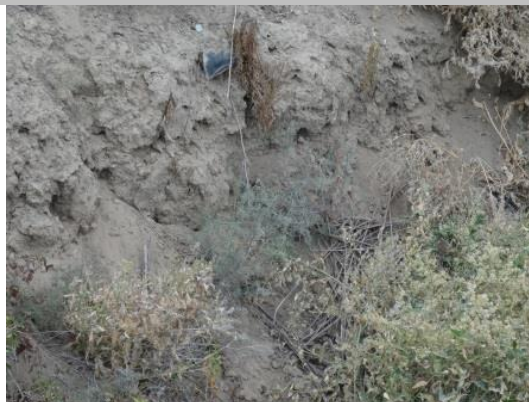
Photo 2 of 2 : SP_2016_RD2095_322_1_20160229_00002.jpg

Close view of the erosion.

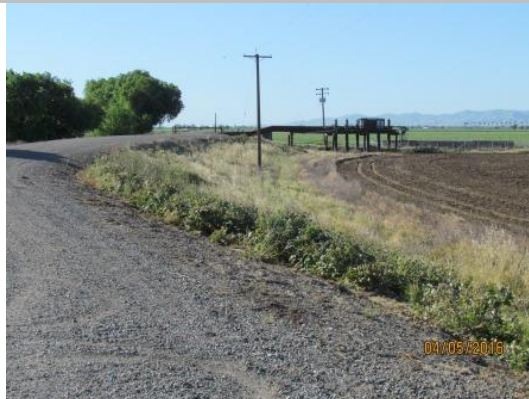
Photo 1 of 1 : SP_2016_RD2095_322_15_20160412_00029.jpg

LM Start	0.75	Rating **	M	Issue No.	15
LM End	0.85	Issue Type +	Ma	Location *	LS
Category	Earthen Levee			GPS Latitude/Longitude	
				Start	End
Item	Vegetation			37.763143 °	37.761794 °
				-121.318652 °	-121.317969 °
DWR ID	DWR_RD2095_01_s_2016_15				
Comment Code					
V1 : Control annual grass and weeds on the levee slopes and easements.					
Inspector Comment

View of the vegetation on the landside levee slope.

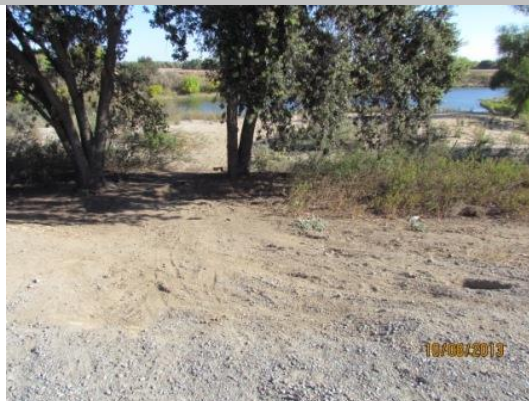
Photo 1 of 1 : SP_2016_RD2095_323_9_20160229_00008.jpg

LM Start	0.03	Rating **	A/W	Issue No.	9
LM End	0.03	Issue Type +	Ma	Location *	WS
Category	Earthen Levee			GPS Latitude/Longitude	
				Start	End
Item	Slope Stability			37.758986 °	37.758986 °
				-121.307854 °	-121.307854 °
DWR ID	DWR_RD2095_02_s_2013_9				
Comment Code					
S3 : Repair the levee slope damaged by vehicle traffic and prevent access where possible.					
Inspector Comment

View of the vehicle tire ruts on waterside levee slope.

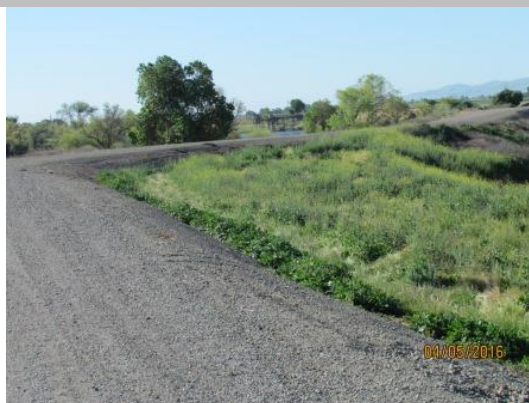
Photo 1 of 1 : SP_2016_RD2095_323_16_20160412_00021.jpg

LM Start	0.20	Rating **	M	Issue No.	16
LM End	0.34	Issue Type +	Ma	Location *	LS
Category	Earthen Levee			GPS Latitude/Longitude	
				Start	End
Item	Vegetation			37.757042 °	37.755242 °
				-121.306133 °	-121.305653 °
DWR ID	DWR_RD2095_02_f_2015_16				
Comment Code					
V1 : Control annual grass and weeds on the levee slopes and easements.					
Inspector Comment

View of the tall vegetation on the landside levee slope.

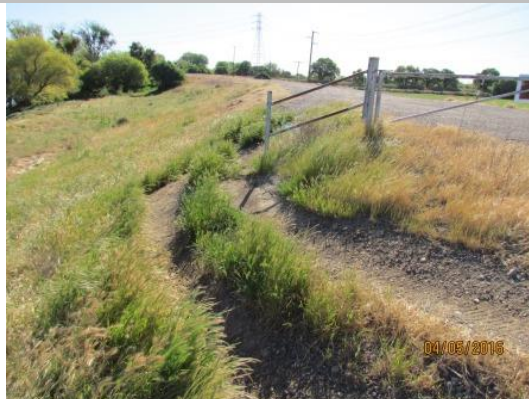
Photo 1 of 1 : SP_2016_RD2095_323_11_20160412_00022.jpg

LM Start	0.82	Rating **	M	Issue No.	11
LM End	0.82	Issue Type +	Ma	Location *	WS
Category	Earthen Levee			GPS Latitude/Longitude	
				Start	End
Item	Slope Stability			37.749644 °	37.749644 °
				-121.301960 °	-121.301960 °
DWR ID	DWR_RD2095_02_s _ 2016_11				
Comment Code					
S3 : Repair the levee slope damaged by vehicle traffic and prevent access where possible.					
Inspector Comment

View of the vehicle tracks on the waterside levee slope.

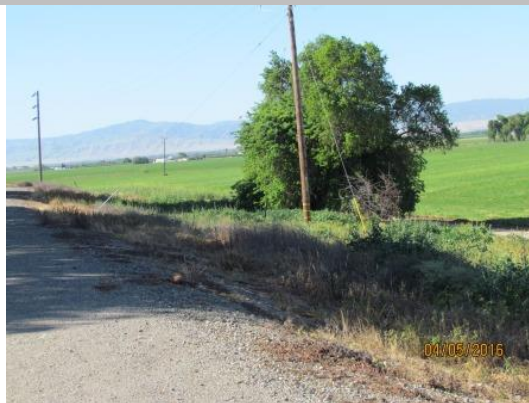
Photo 1 of 1 : SP_2016_RD2095_323_13_20160412_00023.jpg

LM Start	1.05	Rating **	M	Issue No.	13
LM End	2.77	Issue Type +	Ma	Location *	LS
Category	Earthen Levee			GPS Latitude/Longitude	
				Start	End
Item	Vegetation			37.748727 °	37.725845 °
				-121.298954 °	-121.299758 °
DWR ID	DWR_RD2095_02_s_2016_13				
Comment Code					
V1 : Control annual grass and weeds on the levee slopes and easements.					
Inspector Comment

View of the tall vegetation on the landside levee slope.

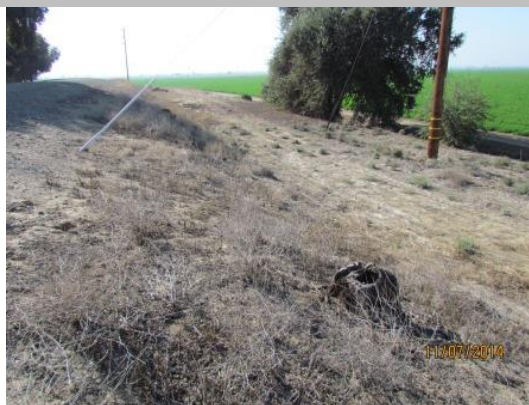
Photo 1 of 1 : SP_2016_RD2095_323_3_20160229_00005.jpg

LM Start	1.09	Rating **	N	Issue No.	3
LM End	1.09	Issue Type +	Ma	Location *	LS
Category	Earthen Levee			GPS Latitude/Longitude	
				Start	End
Item	Trim / Thin Trees			37.748184 °	37.748184 °
				-121.298995 °	-121.298995 °
DWR ID	DWR_RD2095_02_s_2012_3				
Comment Code					
T5 : Tree stumps.					
Inspector Comment					
4 stumps

View of the tree stumps on the landside levee slope..

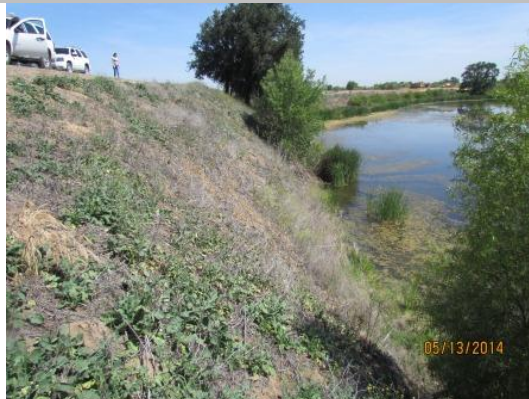
Photo 1 of 1 : SP_2016_RD2095_323_195_20160229_00013.jpg

LM Start	1.35	Rating **	A/W	Issue No.	195
LM End	1.35	Issue Type +	Ma	Location *	WS
Category	Earthen Levee			GPS Latitude/Longitude	
				Start	End
Item	Erosion / Bank Caving			37.744746 °	37.744746 °
				-121.297695 °	-121.297695 °
DWR ID	DWR_RD2095_02_s_2014_195				
Comment Code					
E1 : Note and monitor erosion site.					
Inspector Comment

View of the erosion on the waterside levee slope possibly eroding into the levee prism.

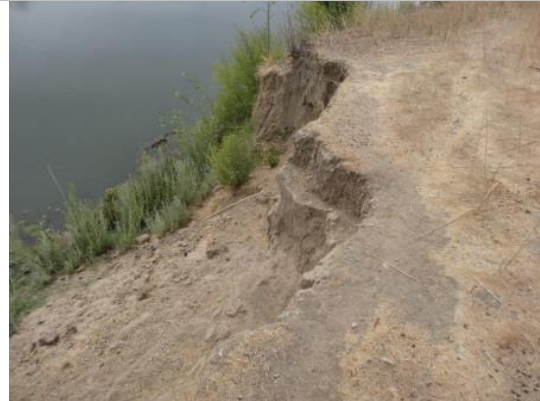
Photo 3 of 3 : SP_2016_RD2095_323_1_20160229_00003.jpg

LM Start	1.74	Rating **	M	Issue No.	1 (cont)
LM End	1.77	Issue Type +	Ma	Location *	WS
Category	Supplemental			GPS Latitude/Longitude	
				Start	End
Item	DWR Erosion Survey			37.740196°	37.740196°
				-121.297662°	-121.297662°
DWR ID	DWR_RD2095_02_s_2016_1

Comment Code					
Inspector Comment					
08/04/2015: No significant change observed. 7/02/2014: No significant change observed. 08/28/2013: No significant change observed. 09/13/2012: The site has been visited by land survey. The vegetation on the site shows the erosion has not developed significantly from the last survey. The site was not visited by boat survey due to the limitation of navigable waterway. 08/23/2011: No significant change observed. 9/22/2010: No significant change observed. There is moderate vegetation growth on the berm. Despite the erosion occurring on the berm, corrective action should be taken before the issue becomes severe. 9/29/2009: Site is immediately downstream of a section of existing rip rap; there is a 20-foot berm remaining; berm will continue to erode unless erosion is mitigated; Site# is the same as RM62.6, LM1.87; recommended for annual assessment, per CES Evaluation 2008 Report 2006: Visited 10/20/06 [2015 Site ID:RD2095U02RM60.62]

Close view of the site.

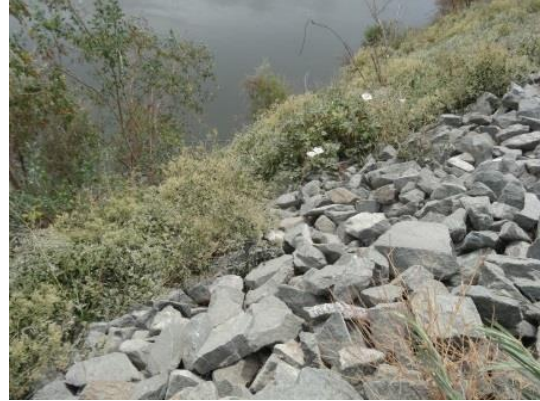
Photo 1 of 1 : SP_2016_RD2095_323_2_20160229_00004.jpg

LM Start	1.82	Rating **	M	Issue No.	2
LM End	1.86	Issue Type +	Ma	Location *	WS
Category	Supplemental			GPS Latitude/Longitude	
				Start	End
Item	DWR Erosion Survey			37.738880 °	37.738880 °
				-121.298260 °	-121.298260 °
DWR ID	DWR_RD2095_02_s _ 2016_2

Comment Code					
Inspector Comment					
08/04/2015: No significant change observed.					
7/02/2014: No significant change observed.					
08/28/2013: No significant change observed. Dense vegetation blocks the visual inspection at the site.					
09/13/2012: The site has been visited by land survey. The erosion is not visible from the levee slope because of dense vegetation at the site. Levee slope is protected by placed rocks. The site was not visited by boat survey due to the limitation of navigable waterway.					
08/23/2011: Dense vegetation makes it difficult to view the possible erosion. No new development was observed on site.					
09/23/2010: At the time of the inspection, the erosion site was difficult to view from the levee. The erosion is located on the bank toe, below the existing rip rap. There were no signs of repair on site, nor has the site been reported to be repaired by the district. Images taken from last year indicate that existing rip rap at the bank toe has sloughed exposing the underlying soils. Weakening of the toe could lead to future bank instability.

08/05/2010: Recommended for annual assessment and monitoring during flood events, per CLRO.					
09/29/2009: No major change observed since last visit; sloughing of the rip rap above toe; erosion begins immediately downstream of existing rip rap revetment; roughly 15-foot berm remains; however, it will continue to erode and eventually intrude into the levee profile if left untreated.					
10/20/2006: Just upstream of where berm starts to widen. [2015 Site ID:RD2095U02RM60.69]

The erosion is not visible from the levee top. The levee slope is protected by riprap rocks.
